# Dry ice blasting of stainless steel

By N.W. Buijs, Van Leeuwen Stainless, The Netherlands

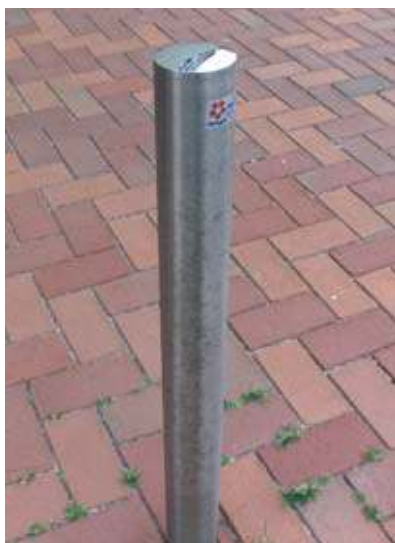
**Picture 1.** A stainless steel AISI 316 post, where all but the polished cap is corroded.

In external environments, stainless steel can sometimes suffer severe corrosion. Nevertheless, as a rule, its performance rates between good and excellent. The latter is especially true when using AISI 316; particularly in inland areas. Problems mainly arise along the coastline, next to railways, and sometimes also close to aggressive gas emissions from factories and vehicles. Another important contributing factor is the condition of the material's surface; the smoother the surface, the greater the material's resistance to corrosion. This is also the reason why ground stainless steel corrodes relatively quickly in maritime environments, while polished surfaces remain in good condition. Picture 1 contains an example of this – the ground tube of the post is somewhat corroded, whereas the polished cap appears to be untarnished. This post is situated on a boulevard along the coast.

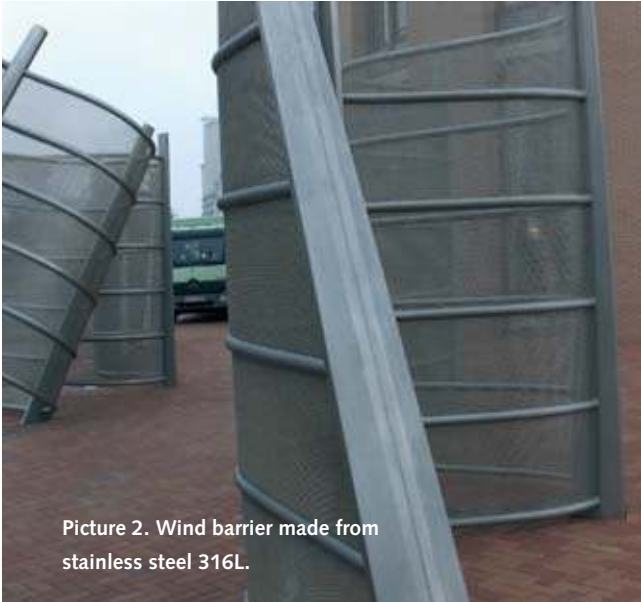
Picture 2. Wind barrier made from stainless steel 316L.

One example that appeals to the imagination is that of a 400 m<sup>2</sup> wind barrier made from stainless steel, situated on a boulevard along the coast (Picture 2). A month after being placed, this 316L stainless steel barrier was already exhibiting patches of corrosion (Pictures 3 and 4). The cause of this was indeed found to be the force of the aggressive aerosols. The rate of corrosion was also accelerated by the material's surface condition, as well as the incorrect attachment of the perforated plates to the tubes, which enabled moisture to collect (Picture 3). Although it may seem that the choice of material was incorrect, if the surface had been polished and there had been no crevices, 316L could, in principle, have been used successfully. Another noticeable thing was that welding had been carried out intermittently. Furthermore, the welds were pock-marked and irregular; a result of applying the MIG welding process, which is preferable to TIG welding when joining perforated plates.

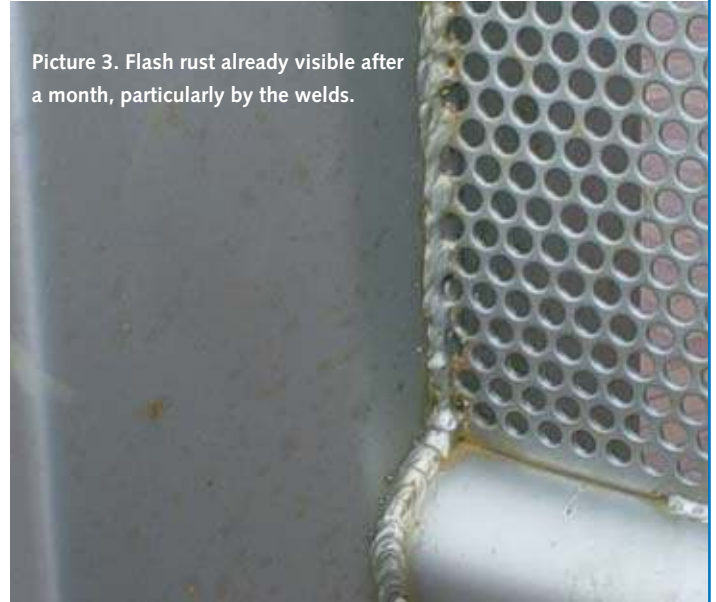
Picture 3. Flash rust already visible after a month, particularly by the welds.

It would also have been better to insert slots in those places not requiring welding, to prevent moisture collection, which did occur in this example. Perforations often have rough edges, which are caused when holes are punched out; this is not very conducive to corrosion-resistance. It would have been

rust was removed effectively within a relatively short period of time, although it had already been left a little too late. In other words, rust should be treated as soon as it is discovered. Pictures 5 and 6 show the result of dry ice blasting, which can be compared to the contents in pictures 3 and 4. It goes without saying that the difference shown is remarkable, if not unbelievable. Even the toughest rust in the

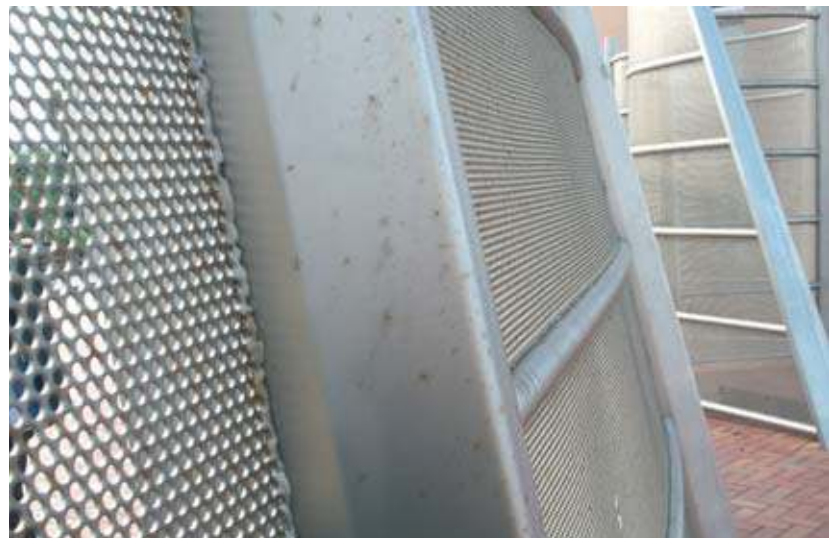
Picture 4. Rust pits showing on the design's posts.

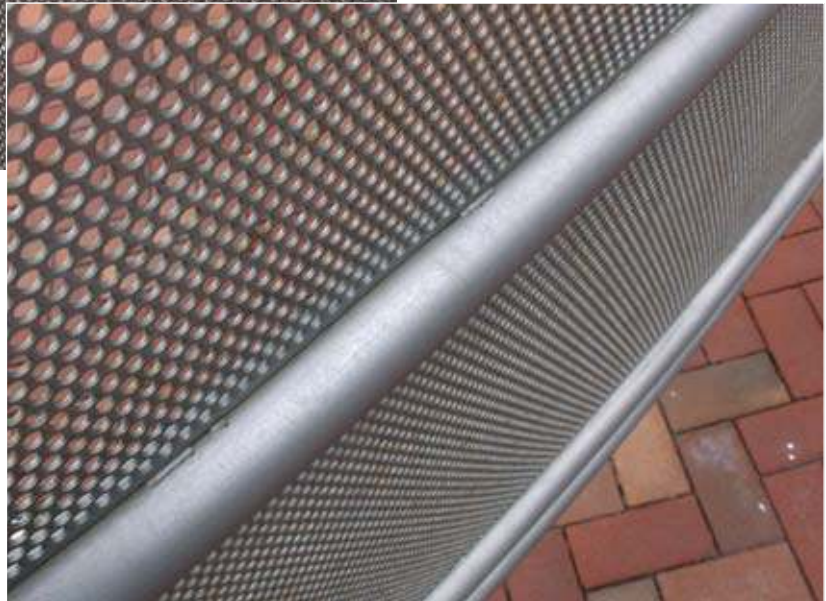
Picture 6. No more rust between the plates and tubes.

the aforementioned wind barrier after it had been cleaned with dry ice blasting, but as you can deduce from pictures 5 and 6, this treatment remains invisible. This coating can easily be applied using a dispenser and its protective qualities emerge once it is 'hardened'. The question remains, however, whether this technical wax offers sufficient protection in the crevices between the perforated plates and the tubes. If in doubt, it would be better to apply a transparent and colourless sealant to these areas.
