Sacrificial anodes for protection of seawater pump caissons against galvanic corrosion

ABSTRACT

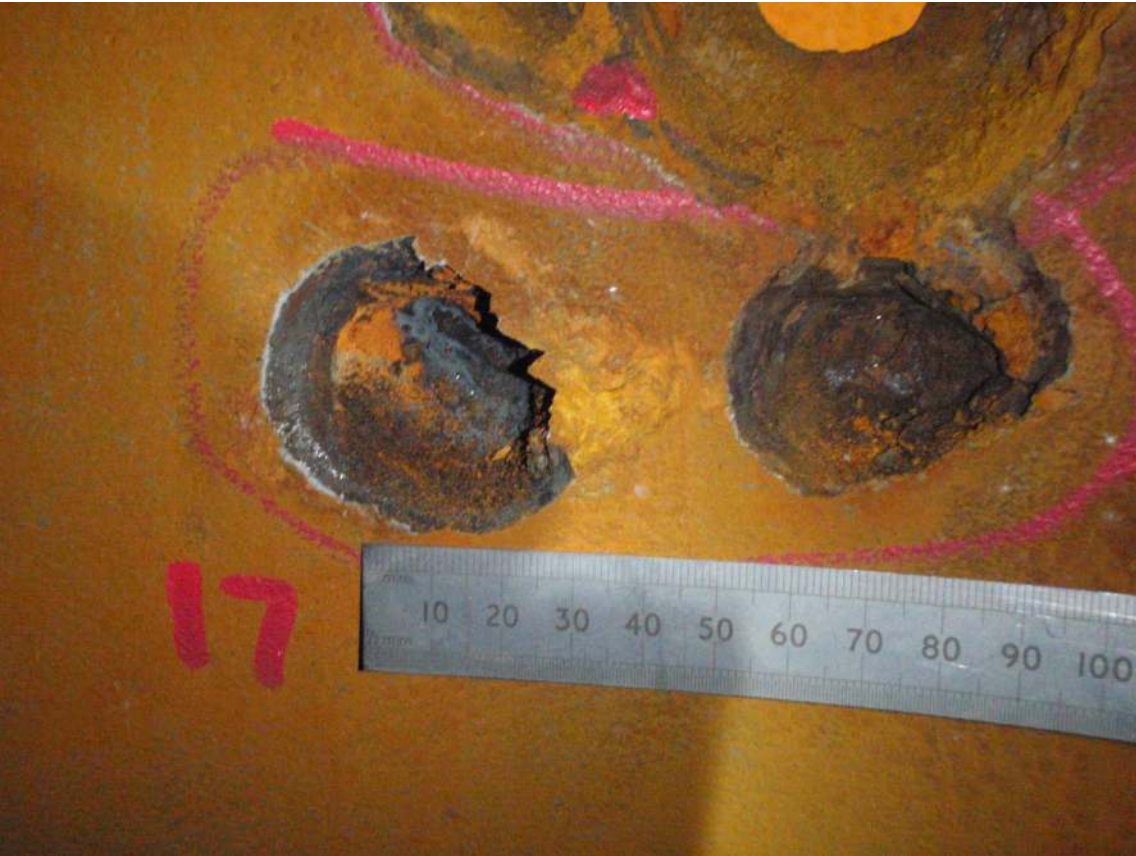
Figure 1: Holes in the caisson within two years lifetime.

If an unprotected caisson has been coated, local corrosion rates will increase strongly. The galvanic current will concentrate on coating damages. The size of the damage can be microscopic small; caisson coating never will stop the galvanic corrosion problem. In contrary, if no cathodic protection system has been installed, the problems will be increased to local corrosion rates of >10 mm/year. Figure 1 shows holes in a coated caisson.

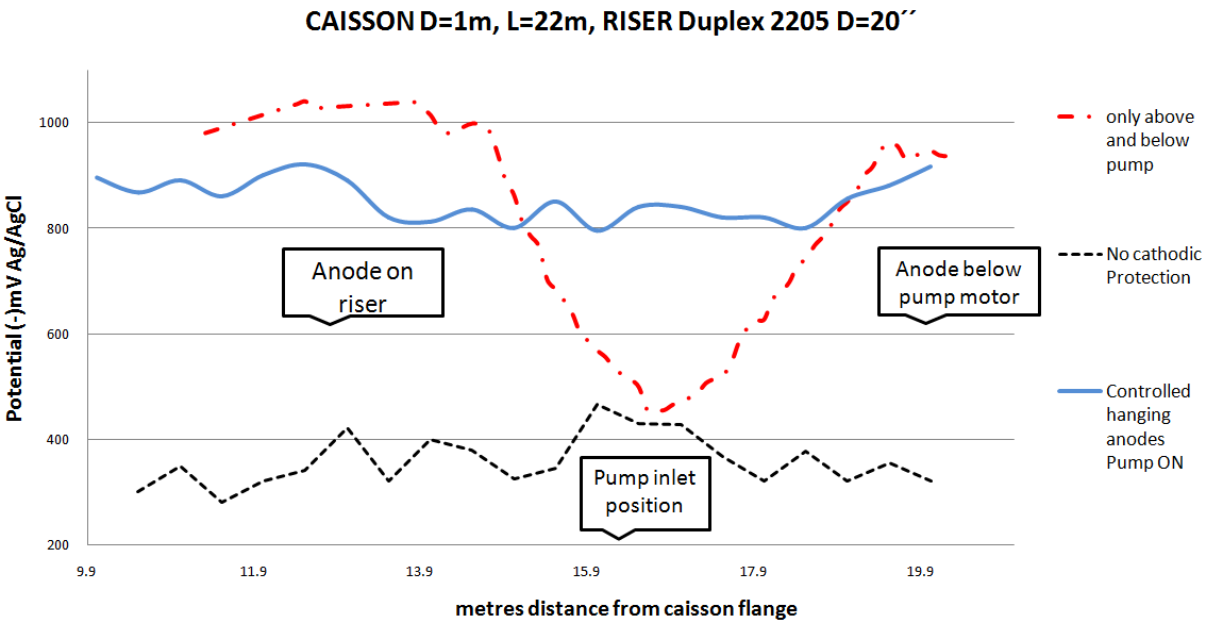
Figure 2: Potential measurements in the caisson; line-----: No cathodic protection. line.-.-.-.-.-: Anodes above and below the pump only. line_____:Anodes are hanging and evenly distributed over entire caisson length.

Installing sacrificial anodes on the riser occasionally is done since the introduction of this type of pumps. Normally a cathodic protection (CP) design or CP measurements were not performed. Effective functioning of the CP system was assumed by installing anodes on the riser, and sometimes below the pump. During diver inspections large holes were found in the caissons on pump inlet position. The reach of the CP electric field is very limited in the narrow annulus between pump/riser and caisson. For that reason, adequate protection will be provided to the area near the sacrificial anodes installed. Depending on annulus dimensions, materials selection and use of coatings, the reach in the annulus is 0,5-1 meter (see figure 2). This implies that anode distance should be 1-2 meter. The length of a pump + motor for a 20" pump is approximately 4 meters. The only way of protecting the inlet area is installing anodes on the pump itself [2]. However; this is not desirable because the pumps and motor are relatively sensitive equipment which should not be impacted by any destabilizing weights such as depleting anodes. For that reason, pump manufacturers may void warranty if anodes are installed. By hanging the anodes in the annulus this problem can be avoided as the pump and motor are not touched by any anode or coating.

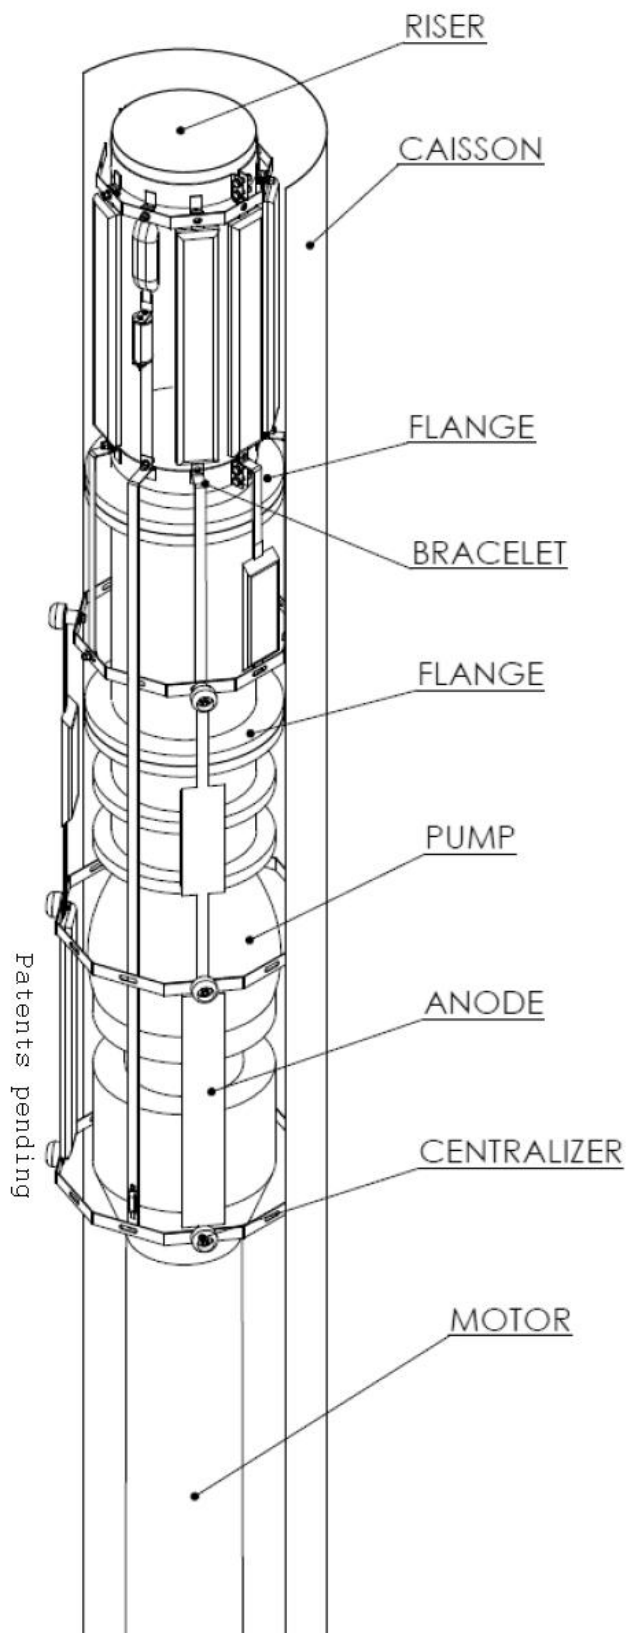
Figure 3: Hanging anode construction.

The anodes are hung on a bracelet that has been installed on the riser. See figure 3 and 4. By using 10-sided stainless steel rings and Nylon centralizers to the caisson, a very stable hanging construction can be made with a very long lifetime. The anode lifetime can be calculated in accordance with DNV RPB401. For a 10 years life relatively low weight is required as the surface to be protected is relatively small. The typical total anode weight for 10 years lifetime on a 20" riser, pump and caisson (all uncoated) is 125 kg Aluminum. It's not the total anode weight that is critical; it's the distribution of the anodes over the caisson surface. The ideal protection potential of the carbon steel caisson is -800 to -900 mV Ag/AgCl. The aluminum sacrificial anodes will polarize the nearby duplex stainless steel or Ni-Al-bronze riser to a similar potential. Figure 5 and 6 show pictures of the anode hanging construction.

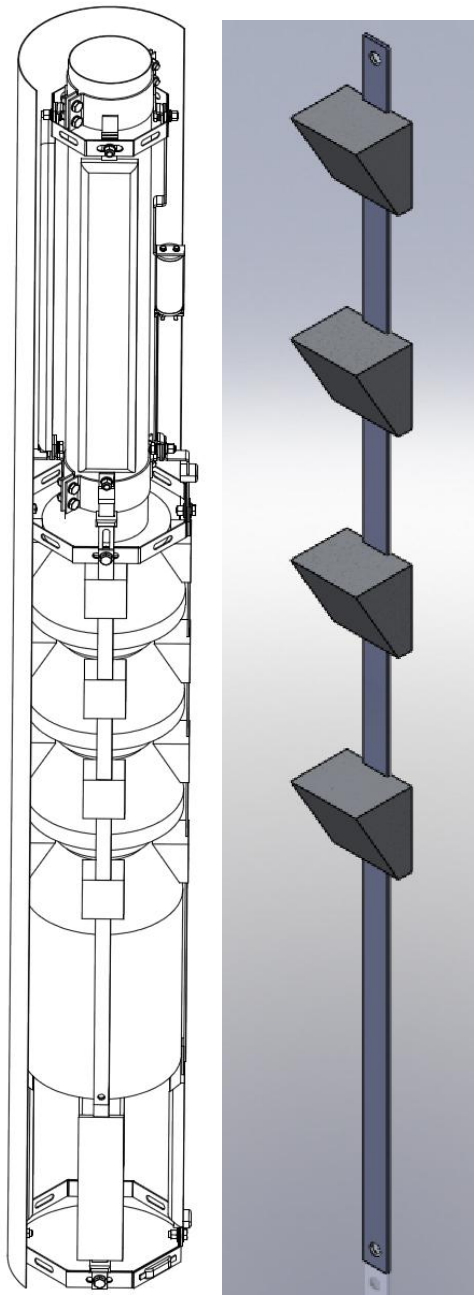
Figure 4: Hanging anode construction, tailor made anodes on diesel firewater pump.

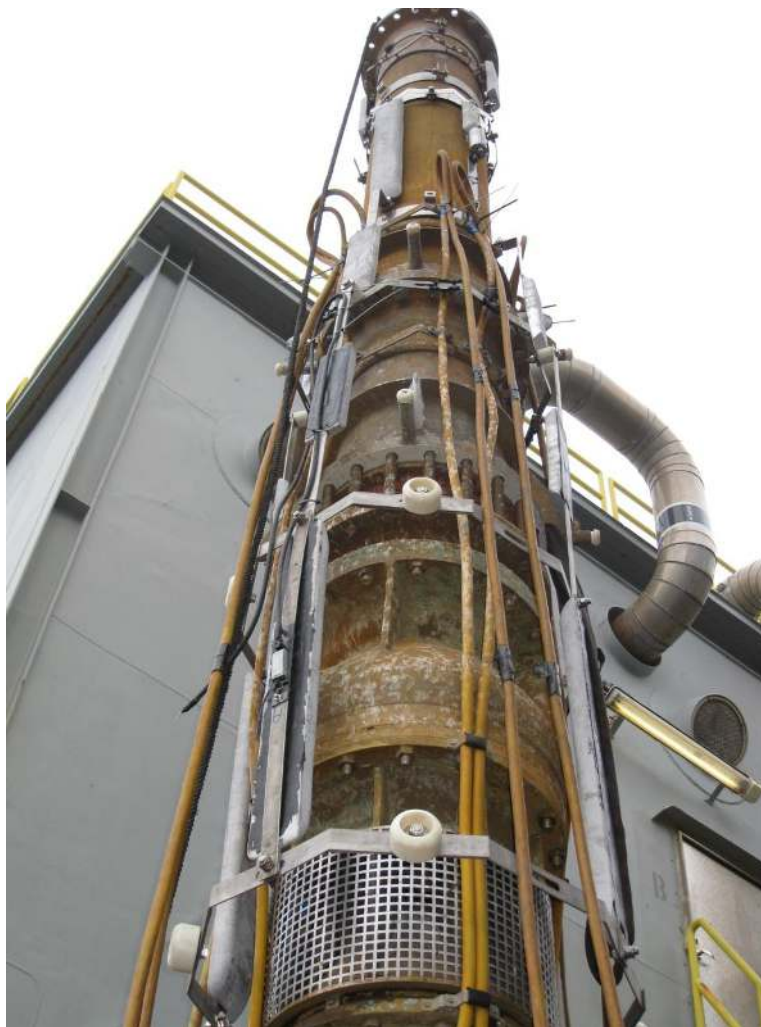
Figure 5: Picture of hanging anode construction. Above: anodes and potential control unit are fixed on riser with bracelet construction. Three rows of anodes are hanging on this bracelet. Small anode left: Zinc-reference anode. Below: pump inlet. Ten sided stainless steel rings with Nylon centralizers keep the construction tight in the caisson.

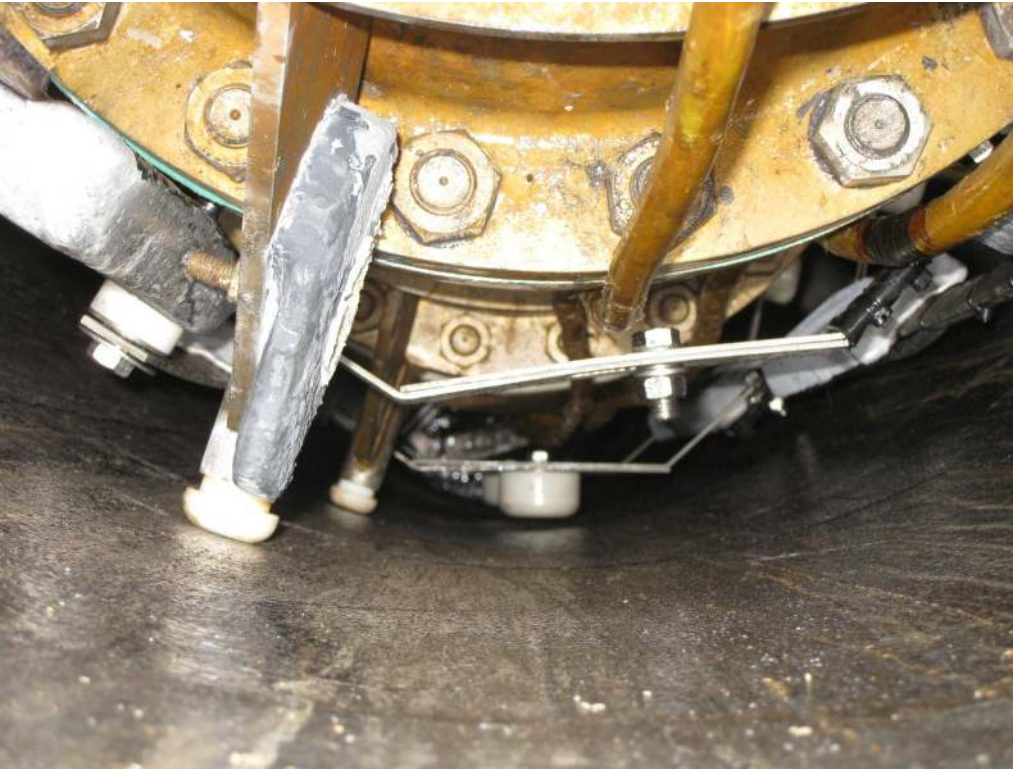
Figure 6: Anodes hanging in the annulus. Note the robust but flexible construction with 10-sided stainless steel rings and Nylon centralizers.

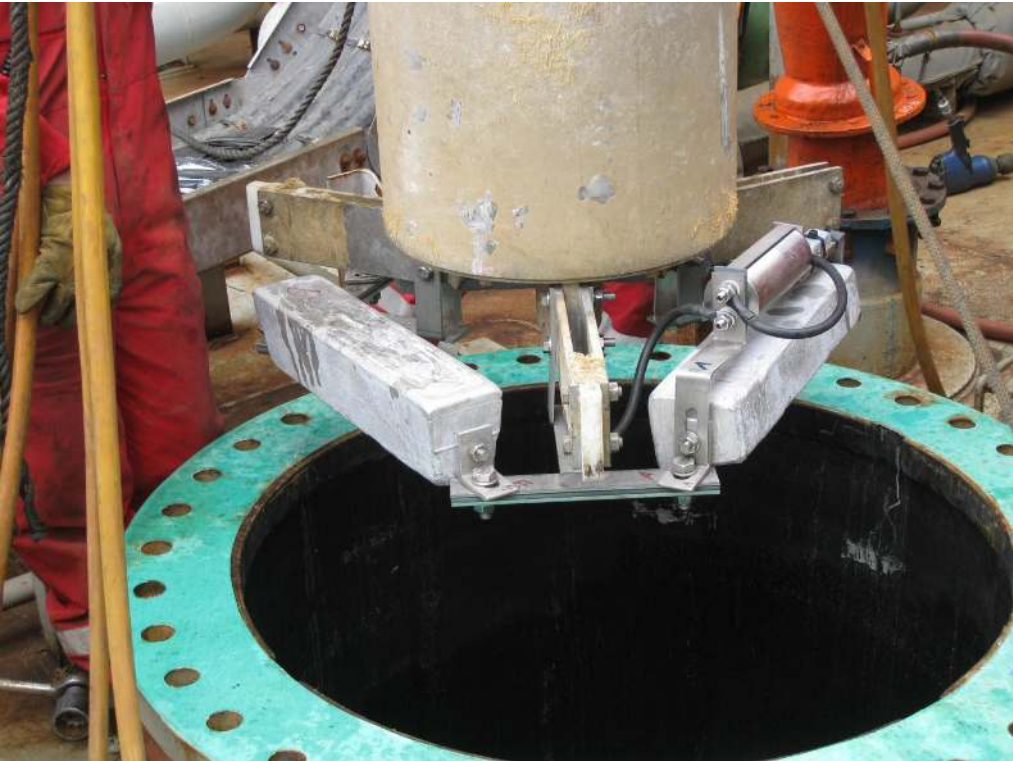
Figure 7: Tank anodes below the pump motor. The stainless steel cylinder is the subsea enclosure with potential control unit. Behind the enclosure a Zinc-reference probe can be noted.

its own depletion (5 years) can be used. The potential control unit also is used for other applications such as fresh water sandbed filters and (sea) water condensers. The electronics have been installed in a stainless steel subsea enclosure. Figure 7 shows an anode assembly with tank anodes and a stainless steel potential control unit with reference probe.
