# The danger of biological corrosion in fire systems & pipelines - Part 2

*By Ko Buijs, Innomet, The Netherlands, [www.innomet.nl](http://www.innomet.nl)*

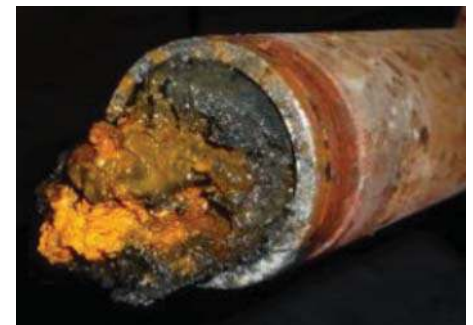
*Figure 3: Steel pipe totally clogged by corrosion products (photo: MIC Europe private company)*

The Biological Activity Reaction Test (BART) has been designed to determine what type of bacteria you are dealing with. This test was designed by Droycon Bio concepts in Canada, and is usually employed by labs and companies who work with corrosion control in the oil and gas sector. Determining which bacteria are involved enables a more targeted treatment. In practice, they are usually dealing with the SRBs. Sprinkler systems are filled with water which usually comes from tanks or a reservoir. The water often remains still for a long periods of time, allowing aerobic bacteria to develop optimally. The corrosion products are blackish and smelly because of the H<sub>2</sub>S formation (rotten egg smell). The resulting reaction products clog the sprinklers (Figure 3).

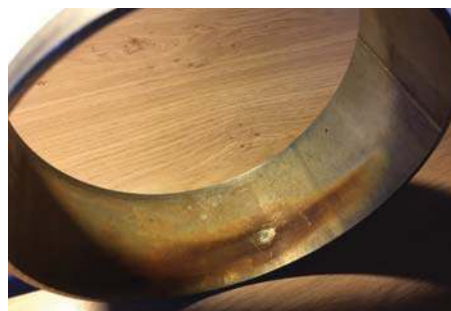
Figure 4: View of the inside of the MIC pierced 6" S10s size 316Ti pipe which had been filled with IJ river water. (photo: Innomet private company)

Fire pipes made out of stainless steel are also very susceptible to MIC, because the fire-fighting water is often in the pipes in an untreated condition for a long period of time. Because of this, the biofilm has time to develop optimally. In this way stainless steel AISI 316L pipes can be perforated in a short period of time. Figure 4 shows a specimen collected from a 6" S10s pipe with the quality 316Ti, which has holes after just six months. Around the hole, one can clearly see a bright spot which is caused by the etching of the sulphuric acid, which could be found under the (now removed) tubercles. The water in the pipes was taken from the IJ River in Amsterdam without being treated. Fire mains in road tunnels are particularly sensitive to this, particularly if the temperature is higher, as in pump rooms

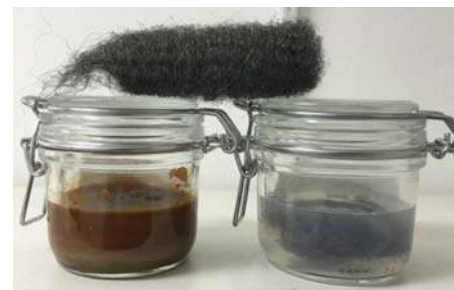
Figure 5: Test with PipeShield on steel wool: on the left is tap water, on the right tap water treated with PipeShield (photo: Innomet private company)

Figure 5 shows steel wool which was immersed in normal drinking water with and without PipeShield. After a couple of weeks, the steel wool dissolved into iron hydroxide in the untreated water, while this is not the case with water treated with PipeShield.
